Extending Autoclave Service Life Beyond the Third Decade

Evelyn Ng
Callidus Group, Australia

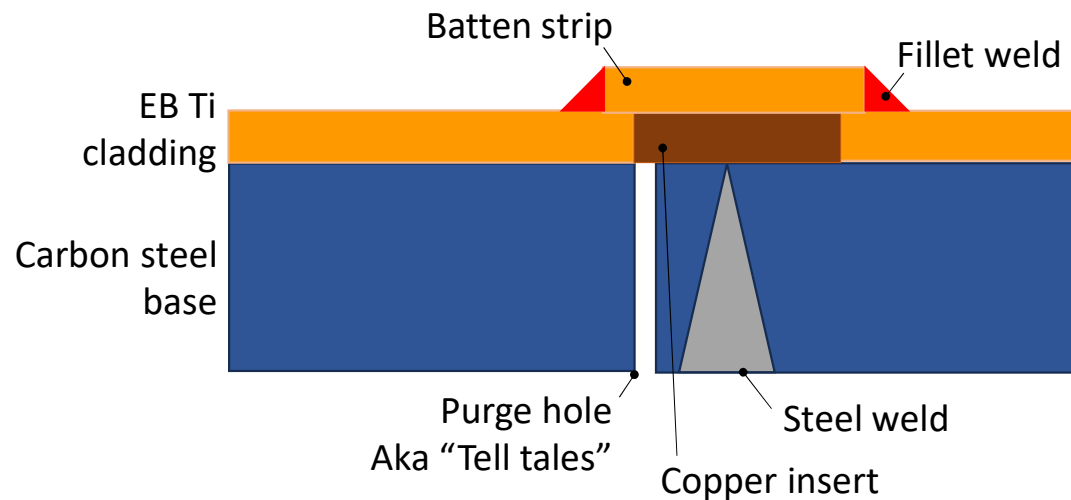
Conventional batten design

- Cracking along the centerline of the fillet weld due to thermal expansion
- Stands proud makes it more susceptible to erosion.

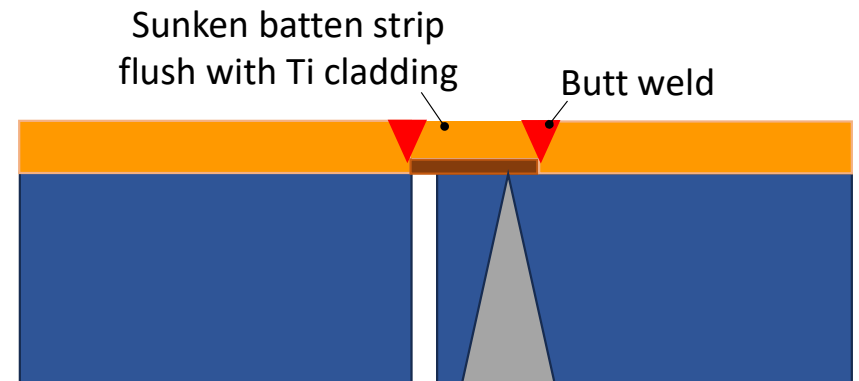
Submerged batten design

- Weld repair of batten will compromise the original Ti cladding.
- Lengthier to repair because butt welds require careful excavation.

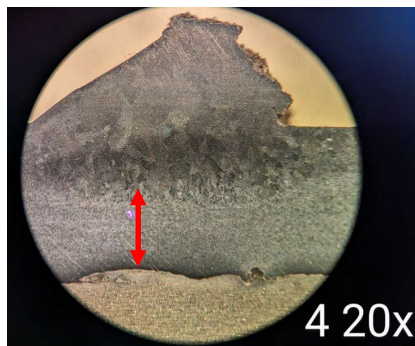
4 mm

Visually, the clad Ti Heat Affected Zone (HAZ) appears to contact carbon steel when clad Ti is 2 mm or less.

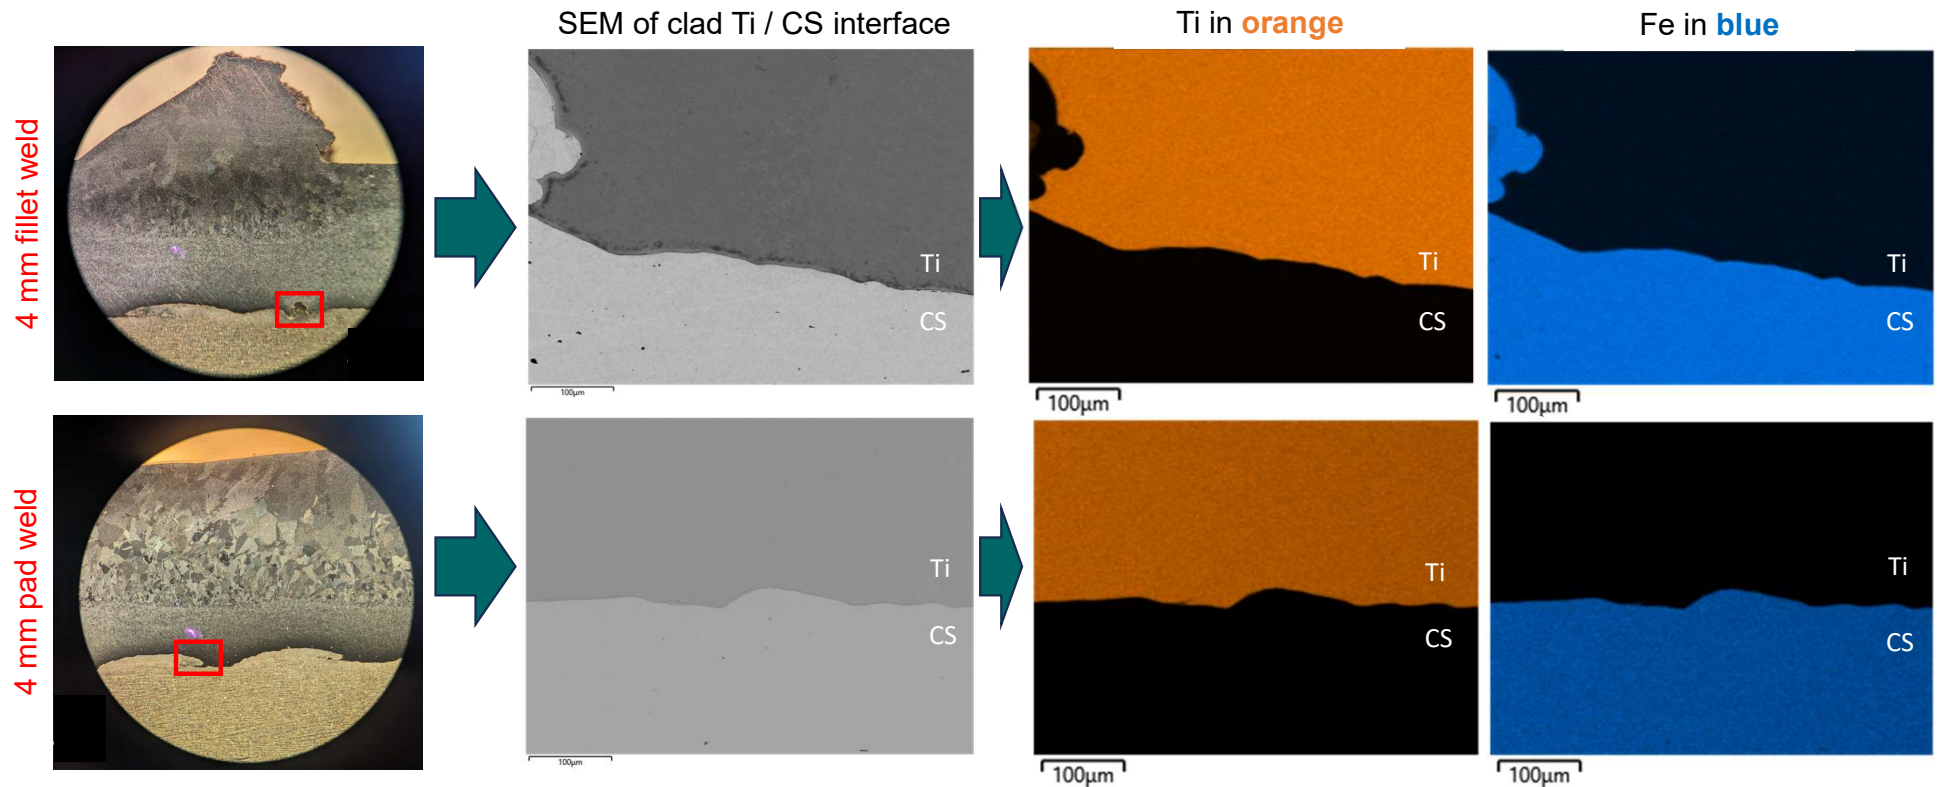
SEM/EDS mapping confirms there is no Fe in welded 4 mm clad Ti.

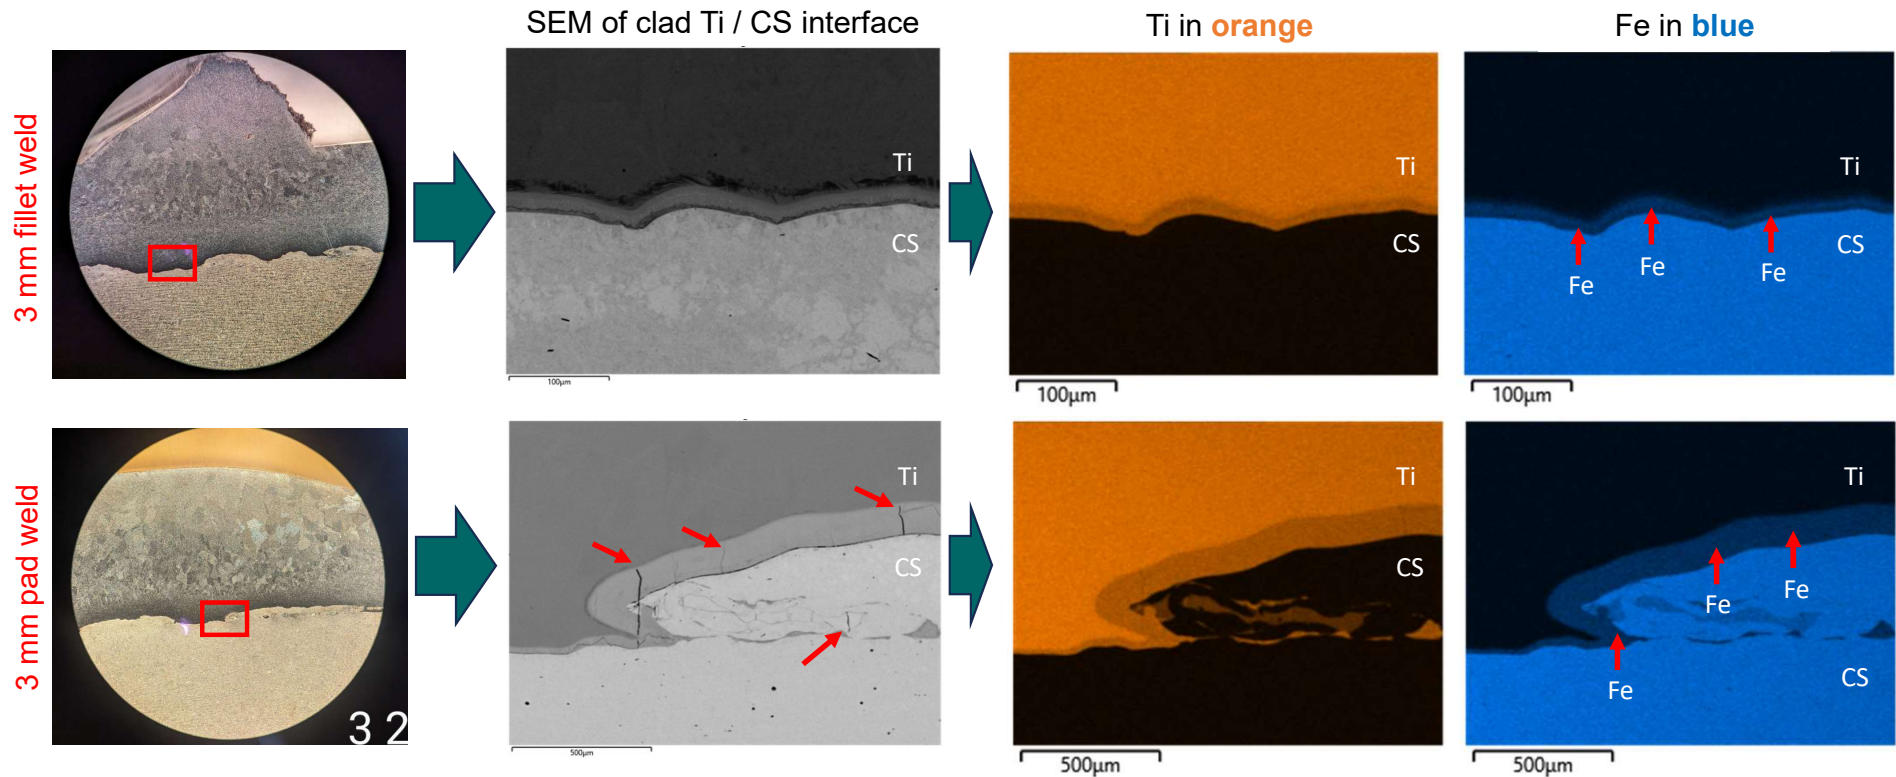
Confirmation there *is* Fe migrating into a welded 3 mm clad Ti, both fillet and pad weld. Cracks were also observed.

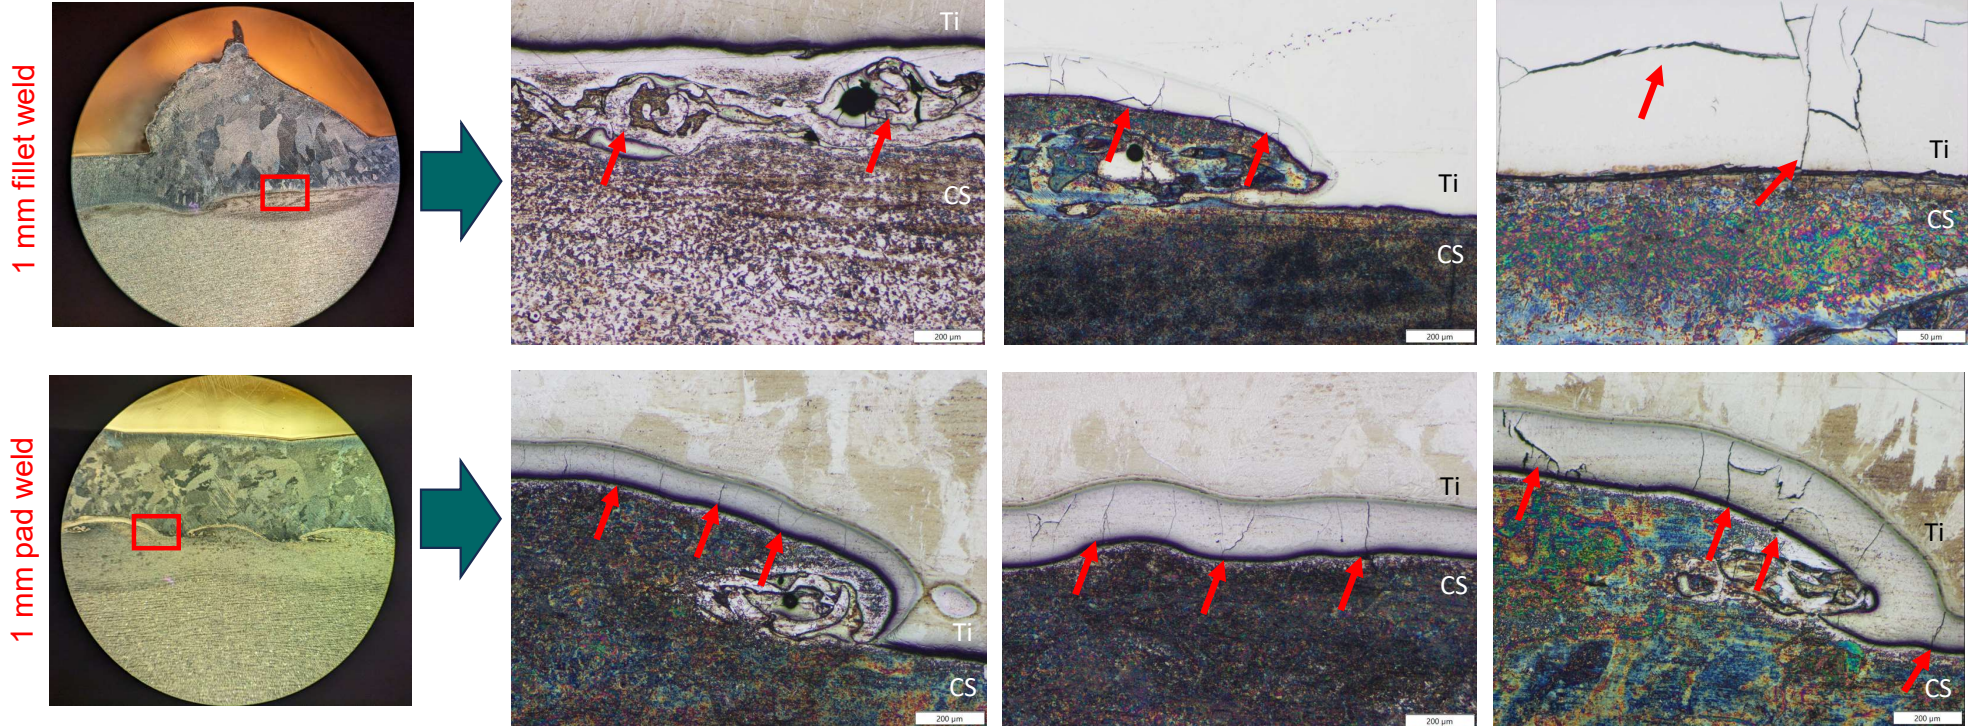
In optical micrographs, extensive formation of intermetallics containing cracks was observed at the clad Ti-carbon steel interface.

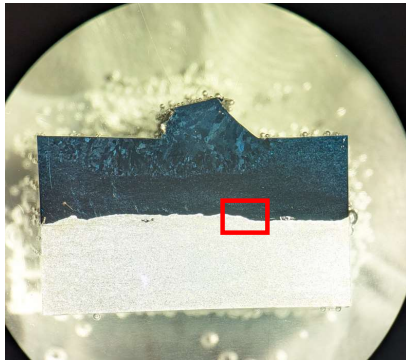
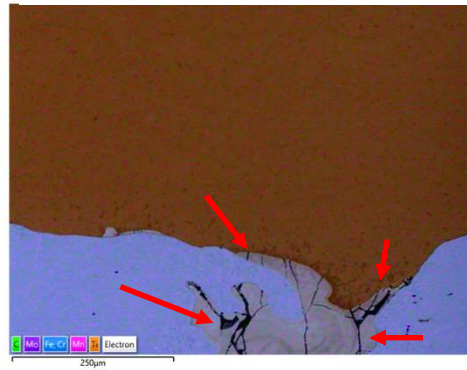
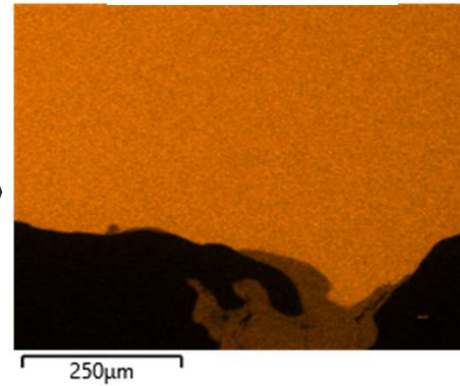
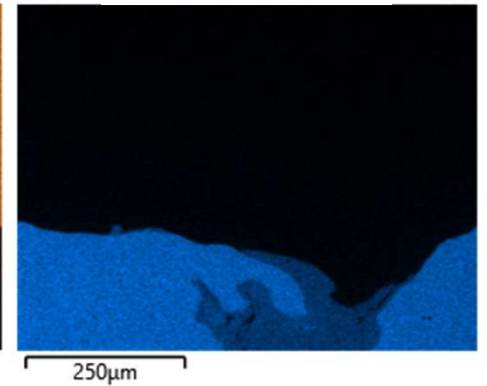
4 mm fillet weld

Intermetallics containing cracks were observed at 4 mm clad Ti thickness.

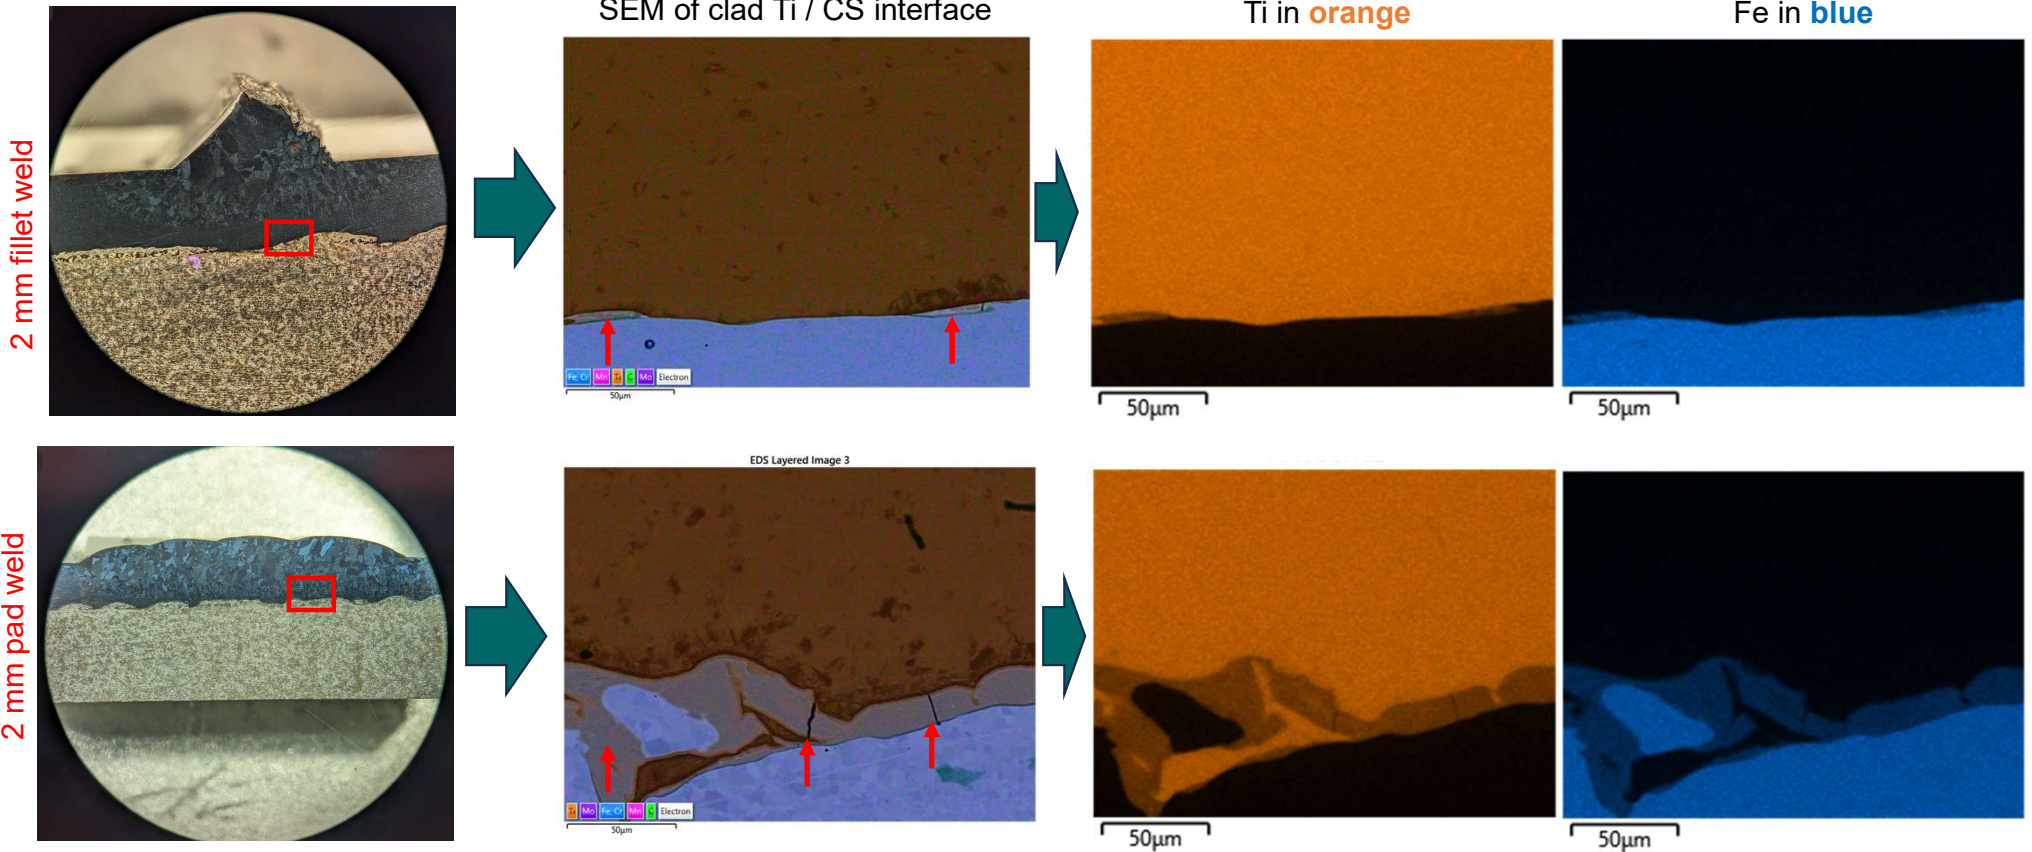
Intermetallics, which included cracks, formed continuously along the interface up to 20 mm in length.
