# Novel Corrosion-Resistant & Erosion-Resistant Coating Qualified for Use in Pressure Oxidation Severe Service

**Evelyn Ng**  
Callidus Process Solutions, Australia

# An innovative two-coating system BM-1600

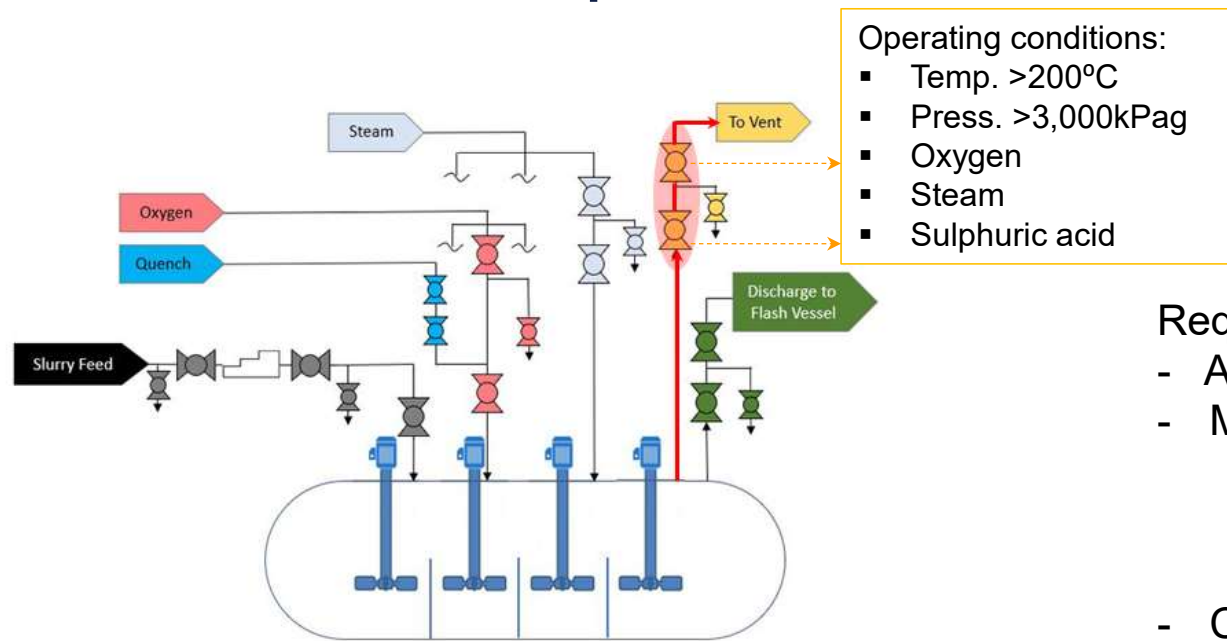
## POx vent isolation challenges:

- Allowable materials qualified for use >200°C?
- Allowable material geometry >200°C?

## Requirements:

- Adequate mechanical properties
- MSBV requirements
  - Dimensional accuracy
  - Spherical contact between ball & seats
- Corrosion-resistant
- Erosion-resistant
- Industry compliant
- Safe for use in oxygen service

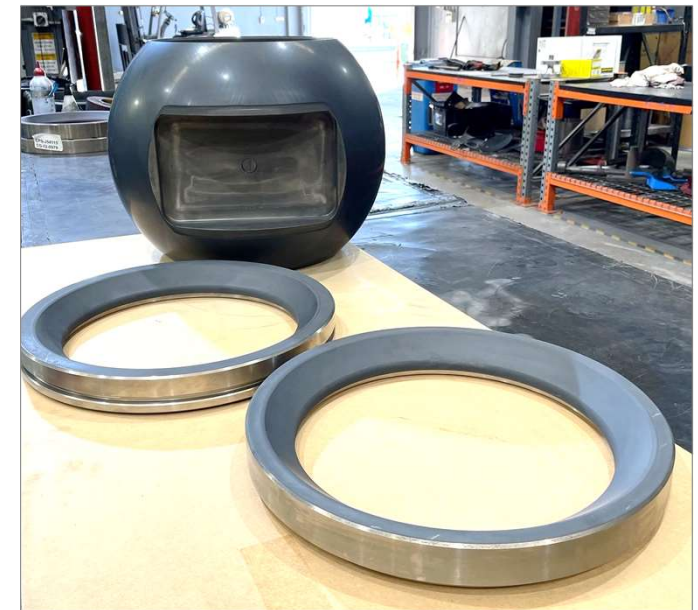
As-applied

# Oxide coating via APS thermal spray

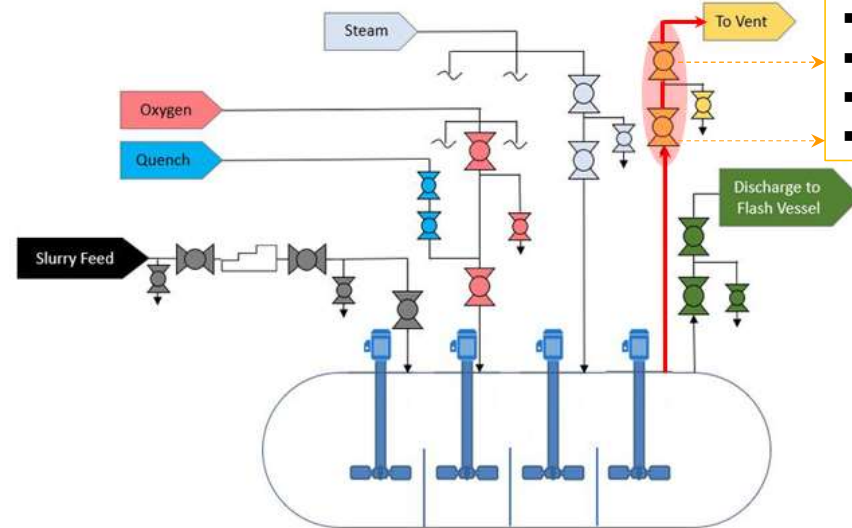
# ASTM G124 to Qualify BM-1600 for POx

- Operating conditions:
- Temp. >200°C
  - Press. >3,000kPag
  - Oxygen
  - Steam
  - Sulphuric acid

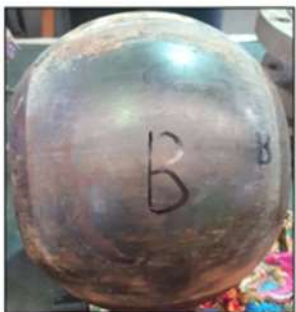
**58 days in-line  
A20 w/oxide coating**  
Corrosion initiated at  
substrate resulting in  
coating delamination and  
loss of sealing capability.

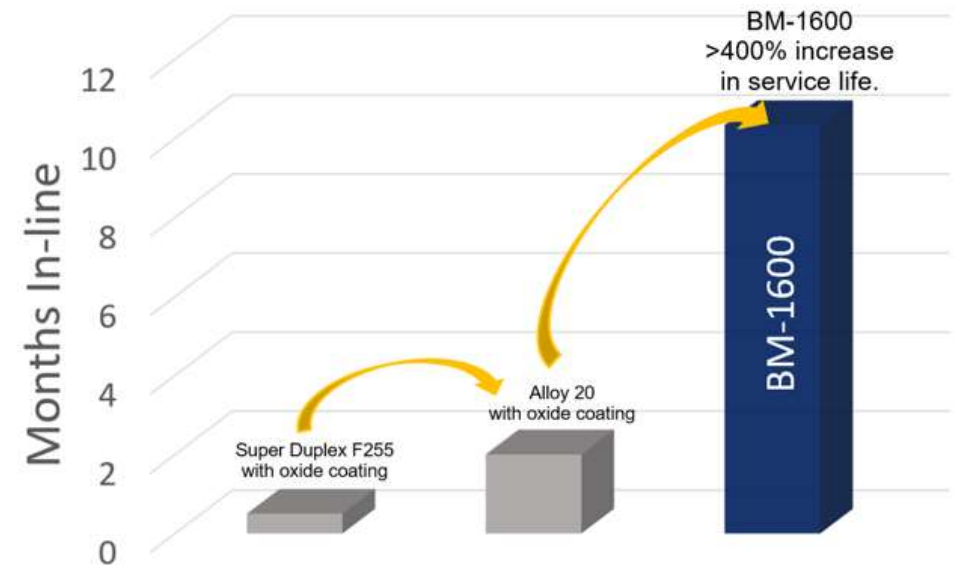
**310 days\* in-line  
BM-1600**  
Coating intact, minimal  
to no corrosion  
observed. Full sealing  
capability.  
\* Valve removed for  
observational purposes.

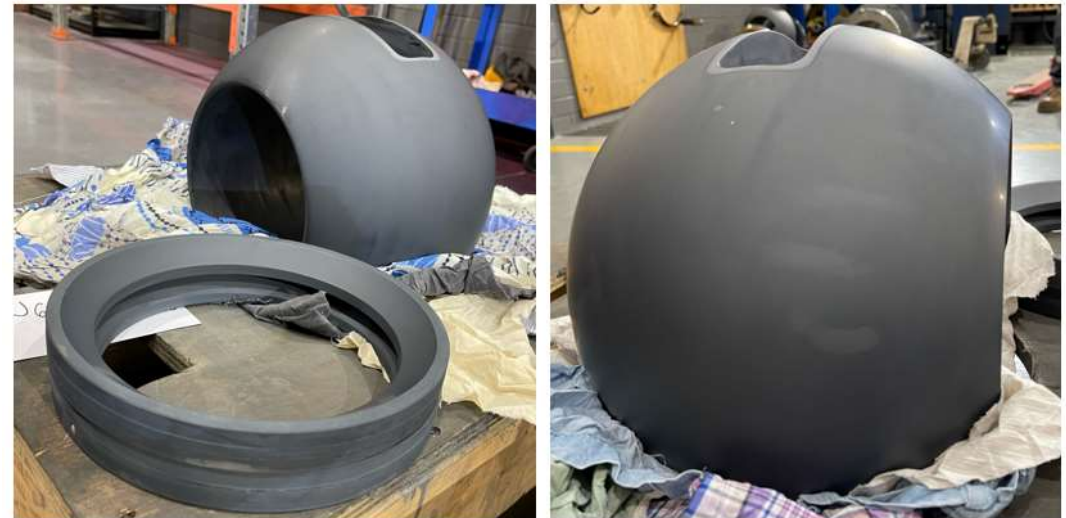
Traditional oxide coating on Super Duplex substrate 4 mo. post-service	Callidus BM-1600 12 mo. post-service
Downstream	Ball
