Beyond limits: Titanium nitride's game-changing role in hydrometallurgical production

Evelyn Ng Callidus Group, Australia

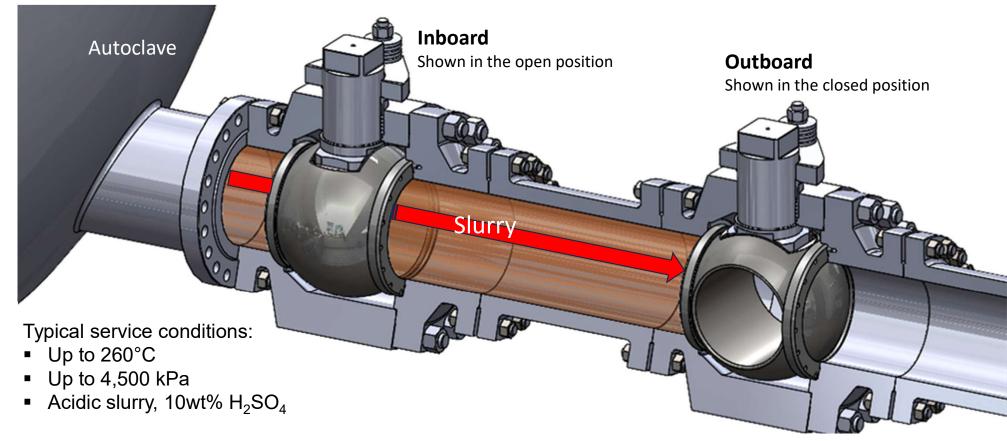
HPAL discharge ball valves are critical equipment

The discharge valves are subject to the most severe conditions.

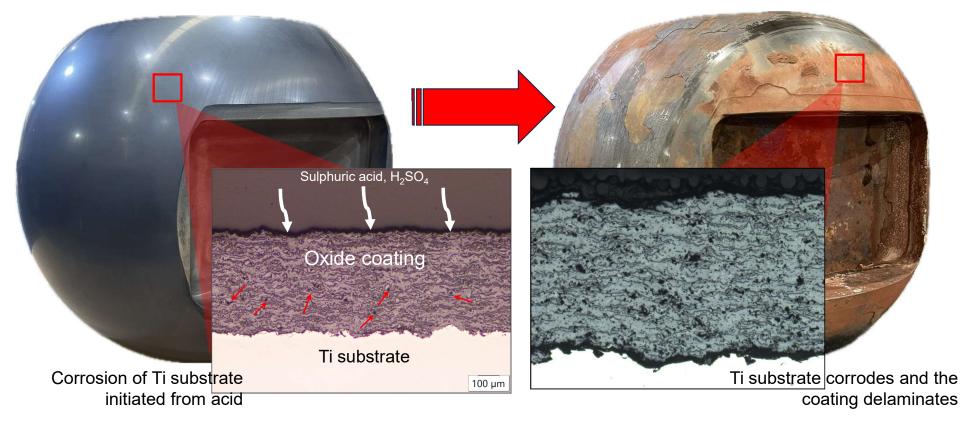
Ceramic coatings are applied on the valve trim

The typical failure mechanism is coating delamination, with a 6- to 12-month lifespan.

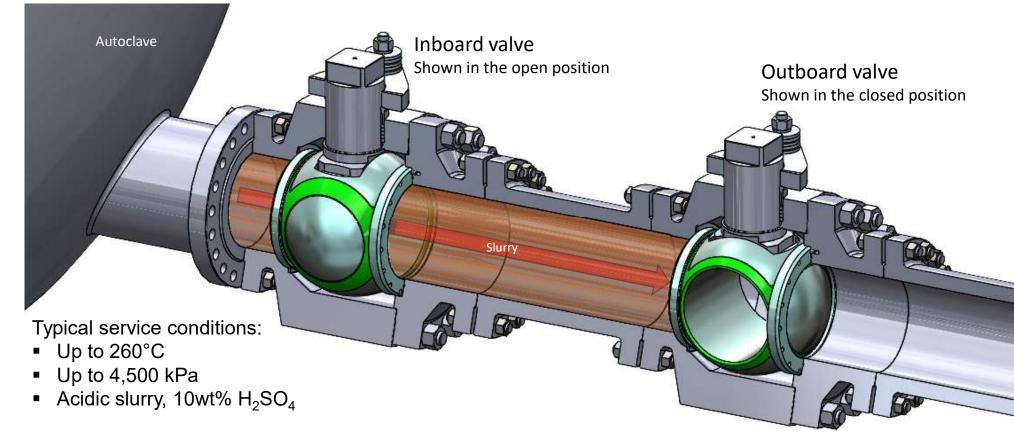
Patented FM-1500[™] applied on discharge titanium valve trim

FM-1500[™] designed for severe service trim

FM-1500[™] installed as a retrofit or repair to a client's OEM valve.

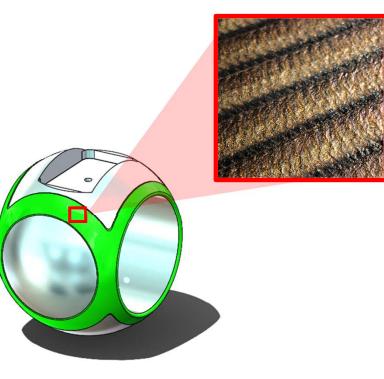
A closer look at FM-1500TM

Innovating with Titanium Nitride. Patented material and design.

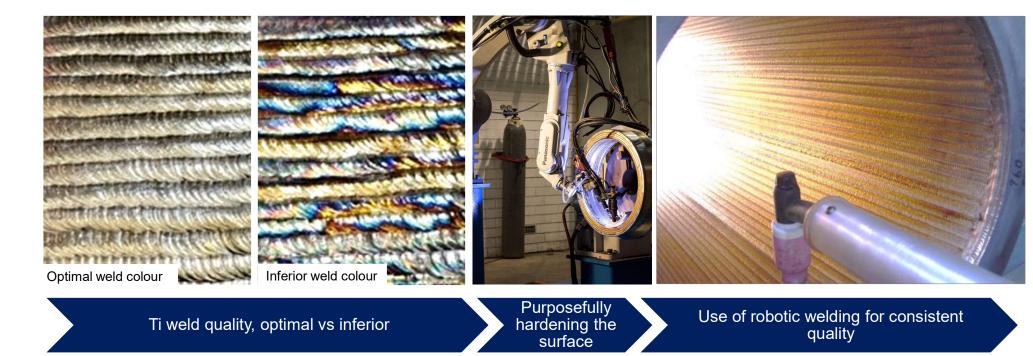
Titanium nitride (TiN) surface modification

Turning an unfortunate event into something purposeful.

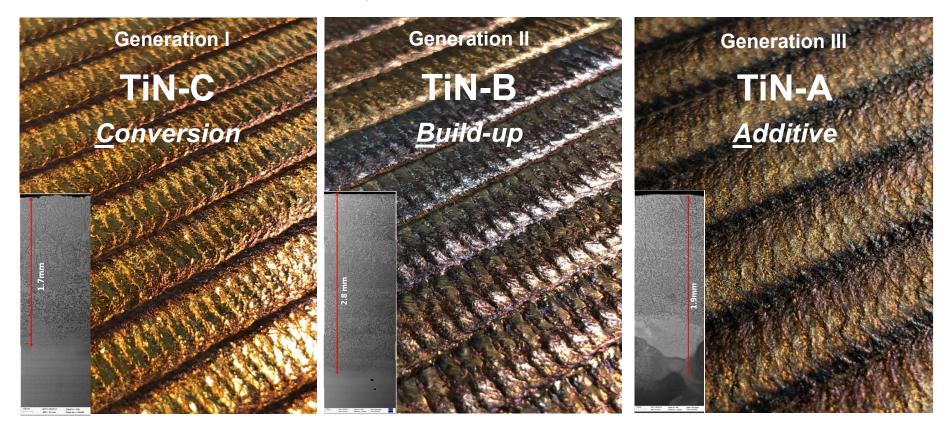
Callidus' suite of titanium surface modifications

Over a decade committed to innovating surfaces for erosion- and corrosion-resistance.

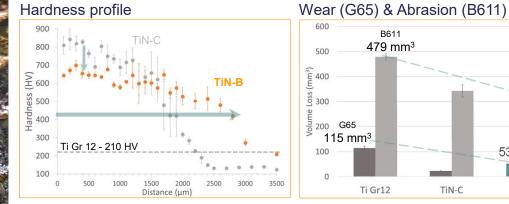
TiN-B material properties

A novel solution to a recurring failure.

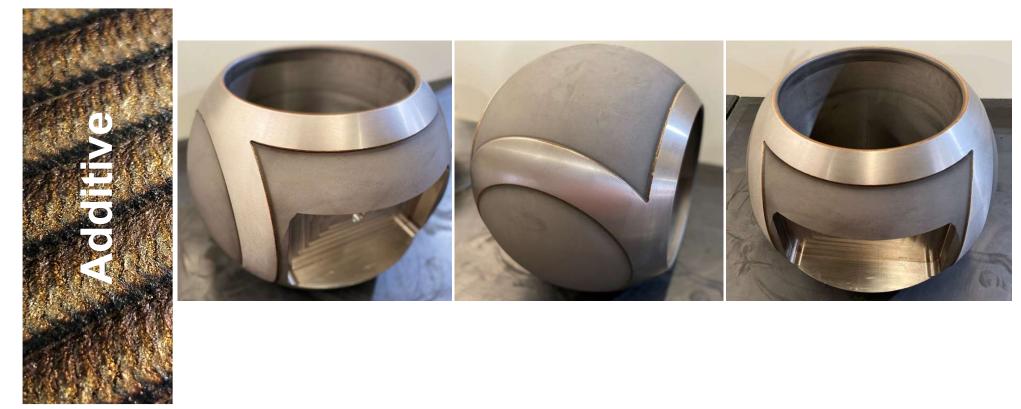
TiN-A on trim is FM-1500[™]

Designed for discharge valve location. Erosion- and corrosion-resistant.

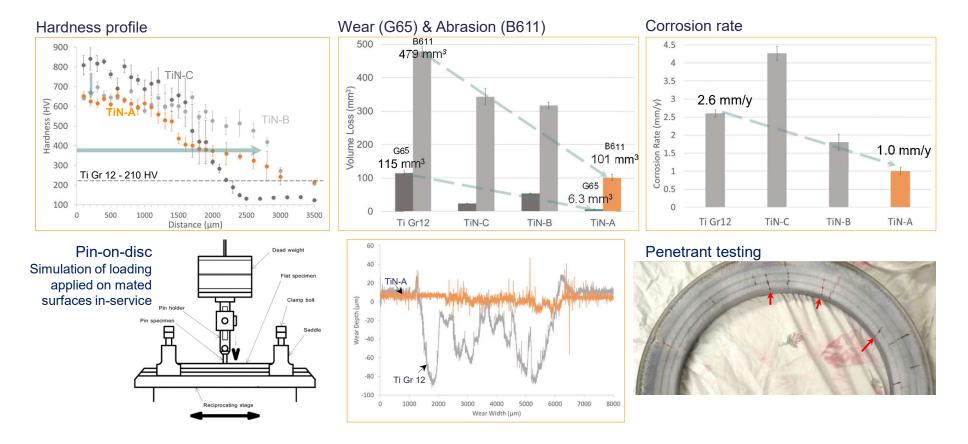
TiN-A material properties

Surpassing previous generations on all counts concerning valve trim.

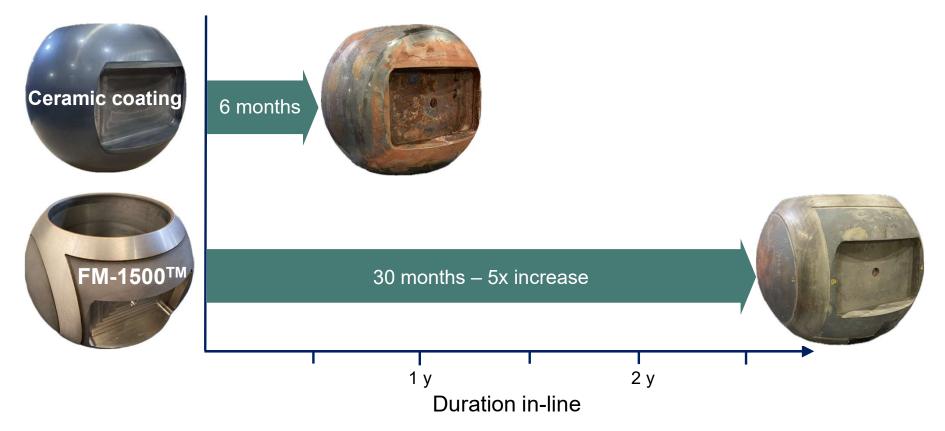
FM-1500[™] trial results

Who wins for best performance?

FM-1500[™] is a game-changer for the discharge valve location.

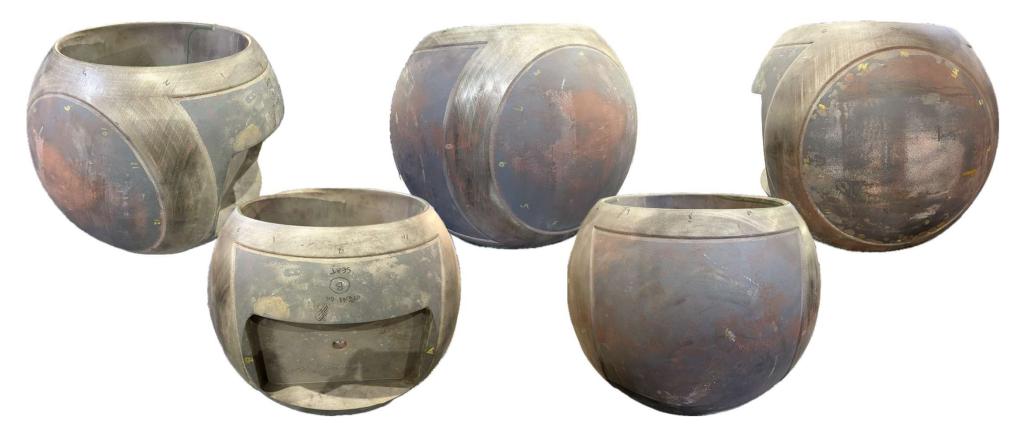
FM-1500[™] inspection after 30 months in service

Bands show superficial surface marks and light scoring. No delamination or galling.

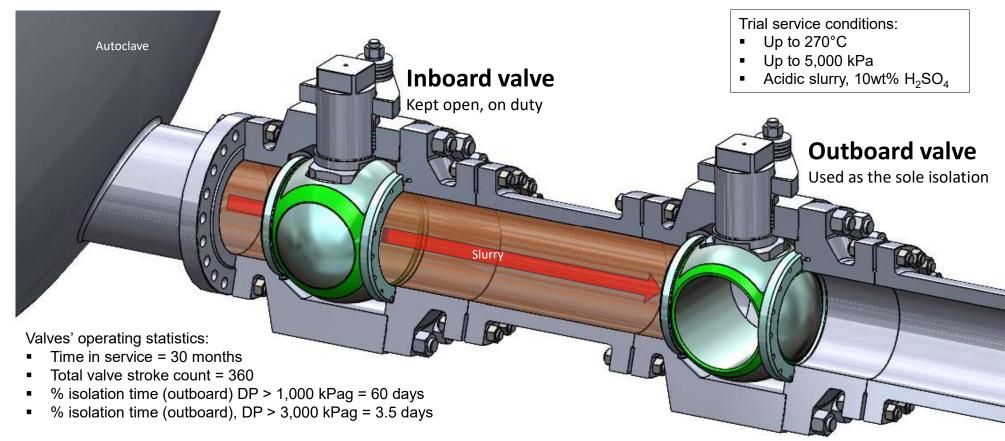
How was the valve operated during the trial?

A case study exemplifying severest of severe service.
