Extending Autoclave Service Life Beyond the Third Decade

Evelyn Ng
Callidus Group, Australia

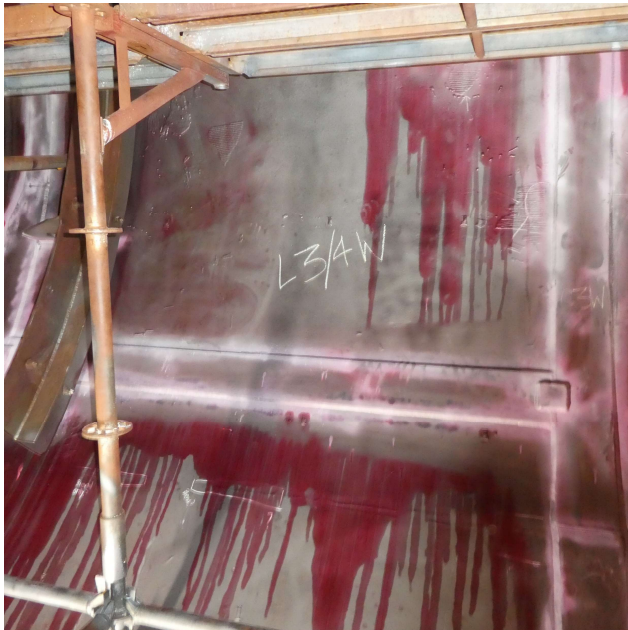
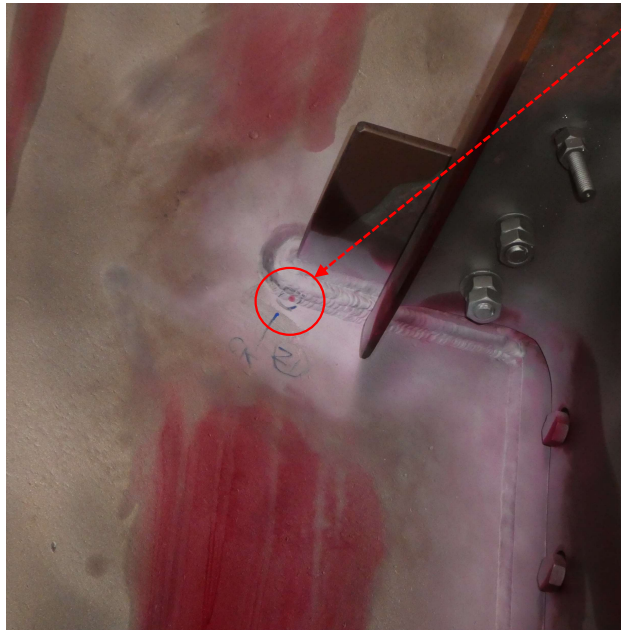
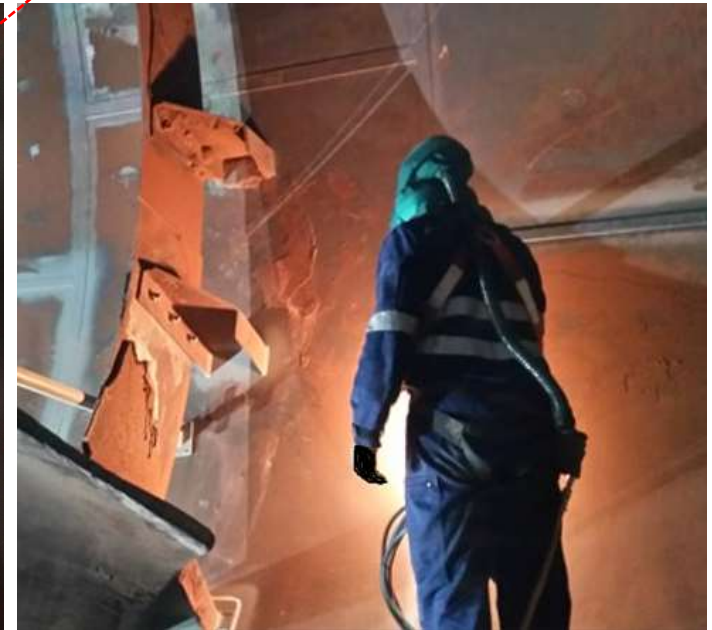
Result: NDT of welds showed no indications

⇒ Cover with developer and
inspect for deviations

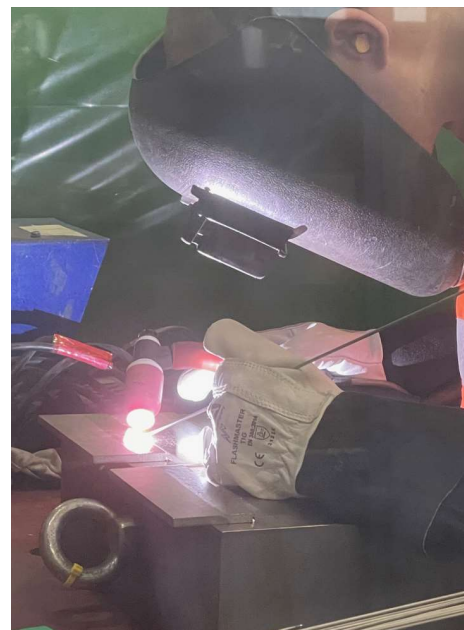
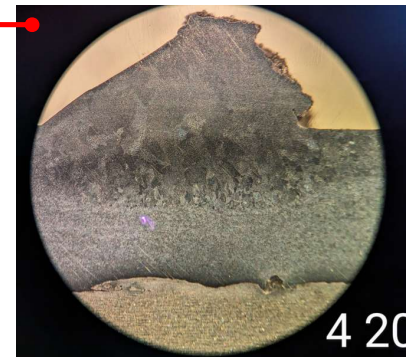
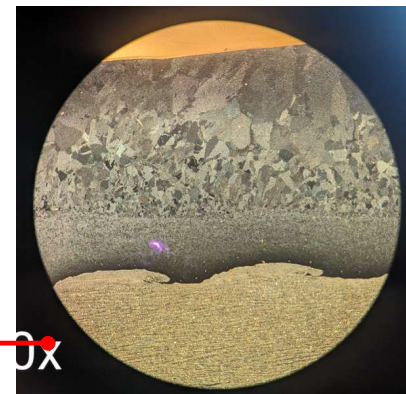
NDT Penetrant Testing and visual inspection

NDT, performed on clad Ti per autoclave shutdown activities, does not indicate what is occurring below the surface, i.e. migration of Fe into Ti.

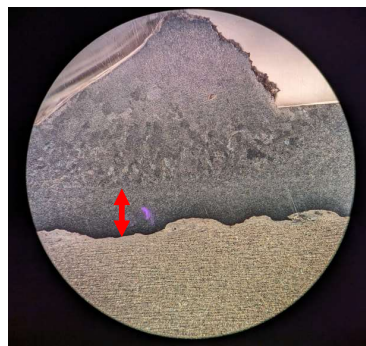
3 mm

Visually, the clad Ti Heat Affected Zone (HAZ) appears to contact carbon steel when clad Ti is 2 mm or less.

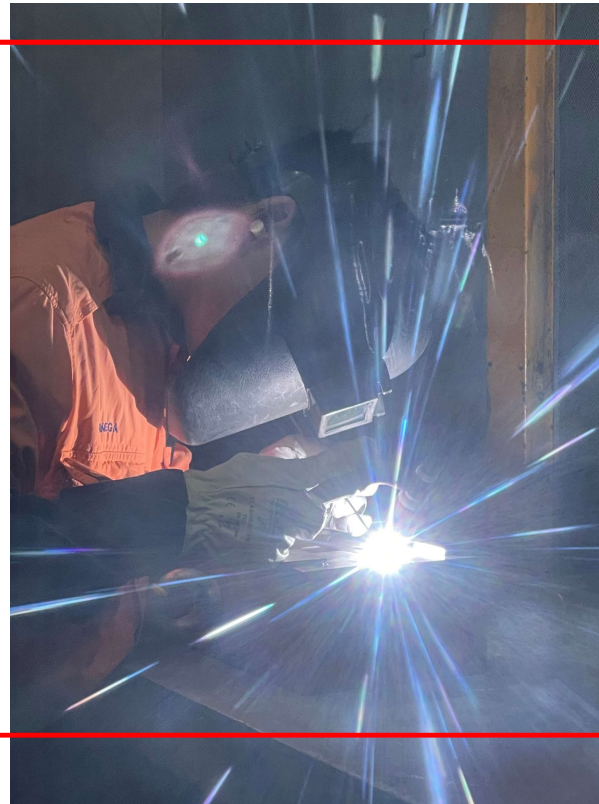
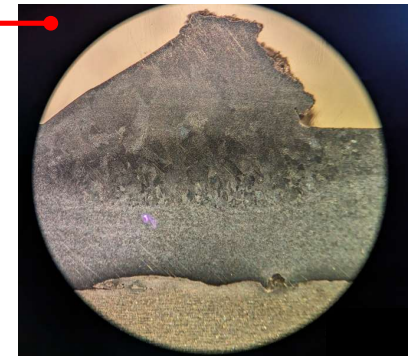
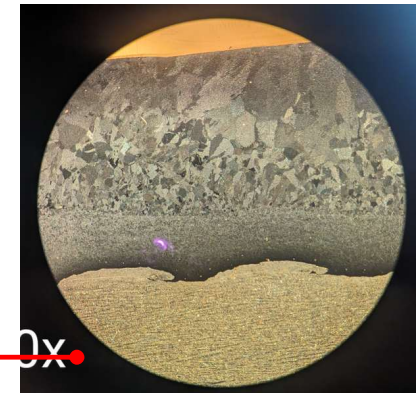
NDT: Penetrant Testing, and visual inspection.

Standard NDT is not indicative of the integrity of welded and repaired Ti cladding. Brittle intermetallics form at a 4 mm clad Ti thickness, contrary to a previous study that determined intermetallics formed at 1.98 mm.
